PATOKA LAKE FOUNDATION REPORT

APPENDIX E

SPECIAL GROUTING ANALYSIS REPORT

ANALYSIS OF GROUTING EFFECTIVENESS AND  
DISTRIBUTION AS OBSERVED DURING EXCAVATION

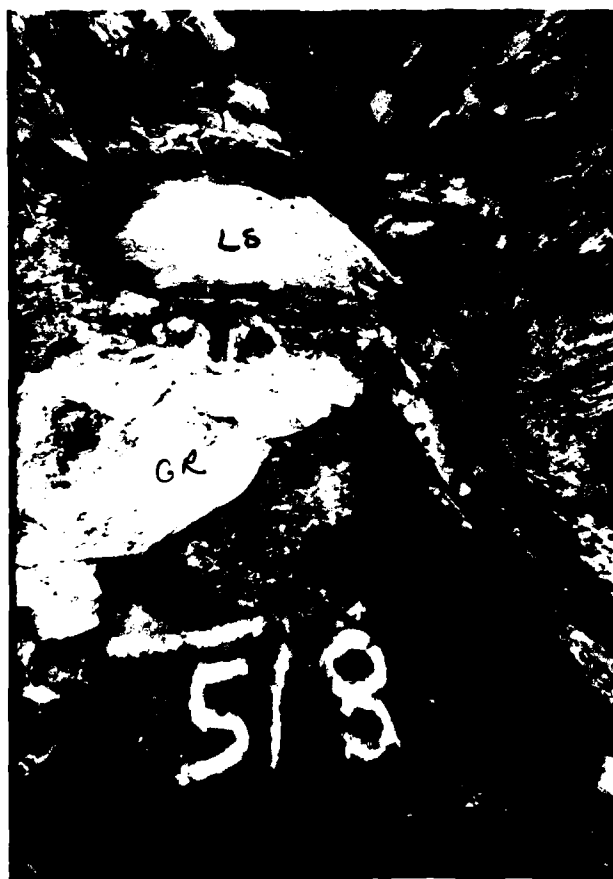
Details of LS pinnacle  
at Sta. 2+20 on US  
wall

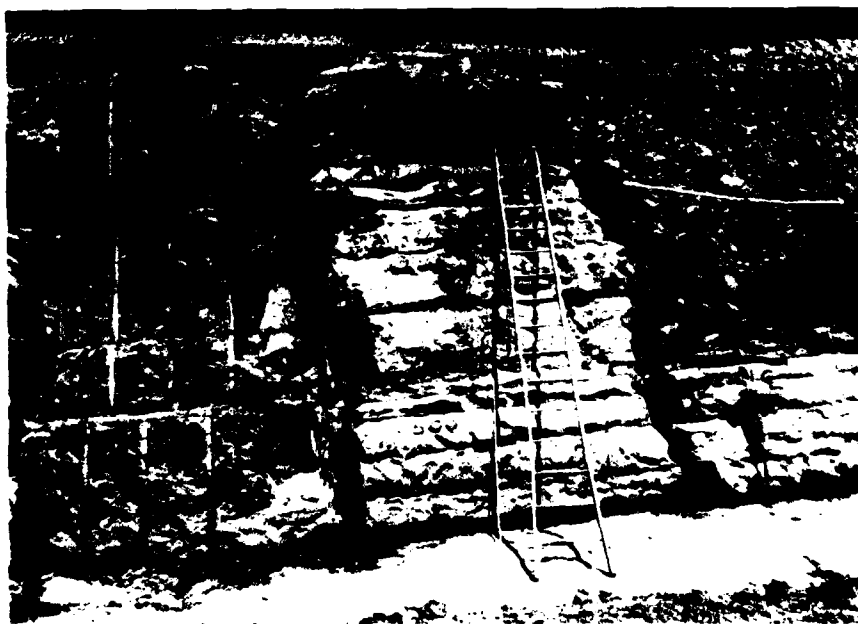
DS wall in LS Sta. 2+45 to 2+80. Vert. face near ladder is contact between OB and LS. Lower portion of solutioned joints have been packed with lean concrete.
